St. John's

Conservation Area Character Appraisal and Management Proposals

Adopted October 2010

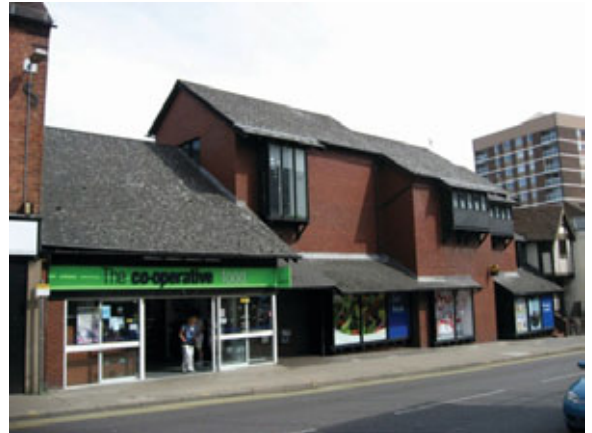
A large volume shop designed to be 'contextual'.

The Co-op supermarket, built in 1979, is an early example of contextual design within a modernist architectural development, where the large internal volume, that is inherent to the retail use, is broken down on the street façade. The use of pitched roofs with varied heights, was a brave alternative to the contemporary flat-roofed orthodoxy. Unfortunately, the quality of the building as seen today, is let down by the use of artificial roofing slates, prevalent at the time, and by poor maintenance.

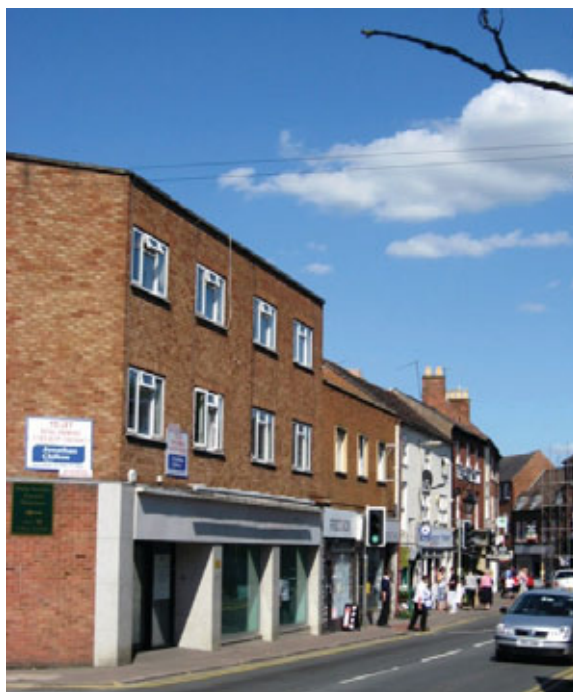
The most prevalent building material is red brick, locally available and popular with the style of 18th century house-building. Good examples of Georgian brickwork can be seen at, for instance, No.25 St John's and No.28 Bromyard Road. Slight variation in the red brick tone adds interest to the street scene. Unfortunately, on some buildings, 18th century and later brickwork has been painted, including No.57 and No.63 St John's. This can change the character and appearance of the building and might cause damage to the bricks. Twentieth century developments, such as the parades of shops at Nos.2-6 Bromyard Road and Nos.19-21 St John's, are built with a buff coloured brick that sadly does not relate to the prevalent local red brick.

Buff bricks used at Nos.2-6 Bromyard Road.

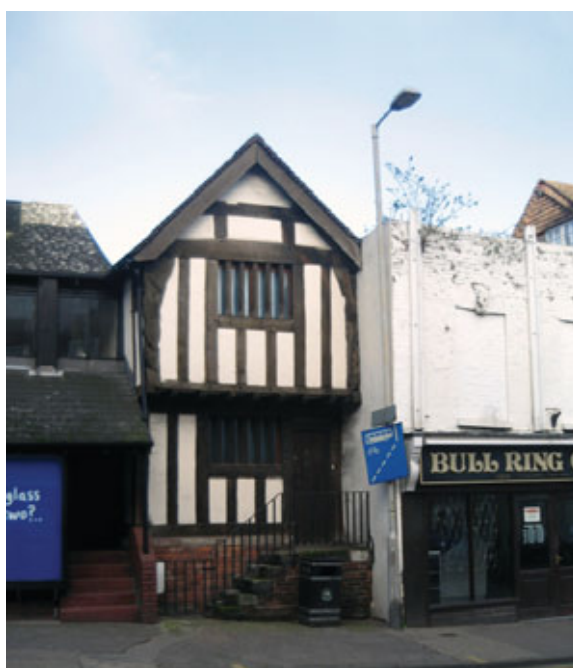
No.6 St Johns, rebuilt framing to front but older fabric is behind.

There are two buildings in the area with external timber framing, both date from the 16th or early 17th century. These are No.6 St. John's, and Nos.43 - 49 St John's (restored in about 1980) which, with the exception of the Commandery, is probably the only surviving medieval hall in Worcester.

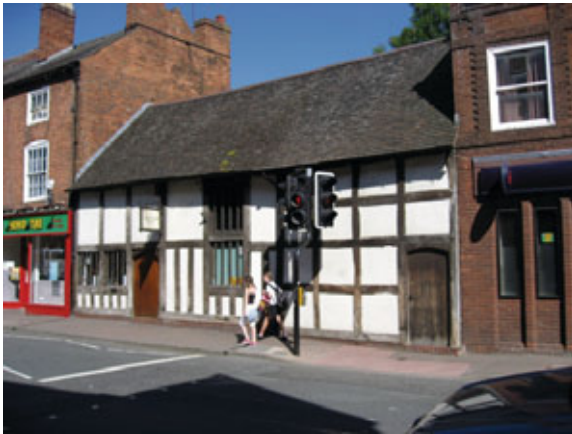
A rediscovered 'hall house' at Nos.43-49 St Johns

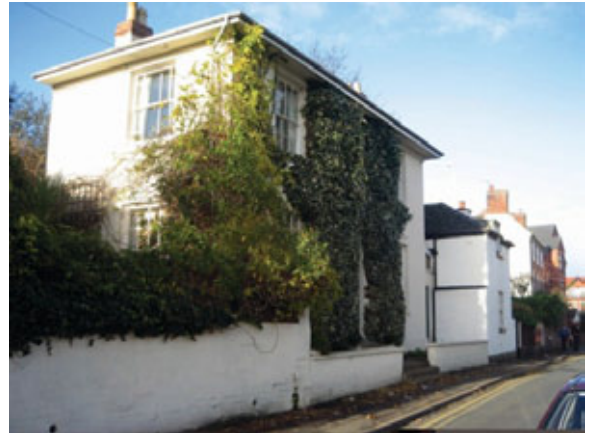
Stucco was a popular facing material at the start of the 19th century. Though there are examples of stucco at No.1 Malvern Road and No.12 Bromwich Lane, the broader incidence of this form of plaster is negligible. Small areas of tile-hanging can be seen in the gables of the former vicarage.

Stucco finish at No.12 Bromwich Lane.

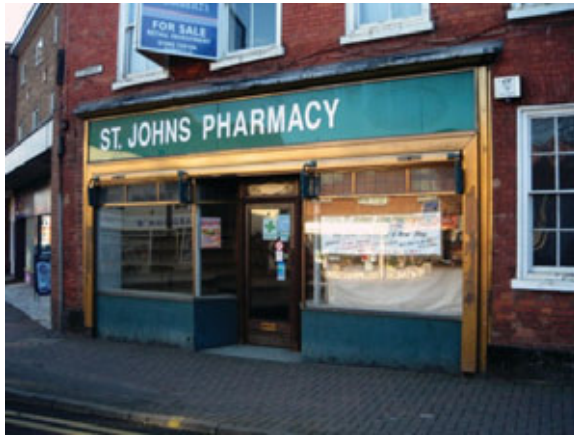
Examples of these are to be found at Nos. 7, 9, 11, 11a, 29, 33, 41, 41a, 46, 48, 54, 65 and 67 St John's. Good quality mid-20th century shopfronts are at Nos. 23 and 87.

Mid-20th century shopfront, No.23 St John's.

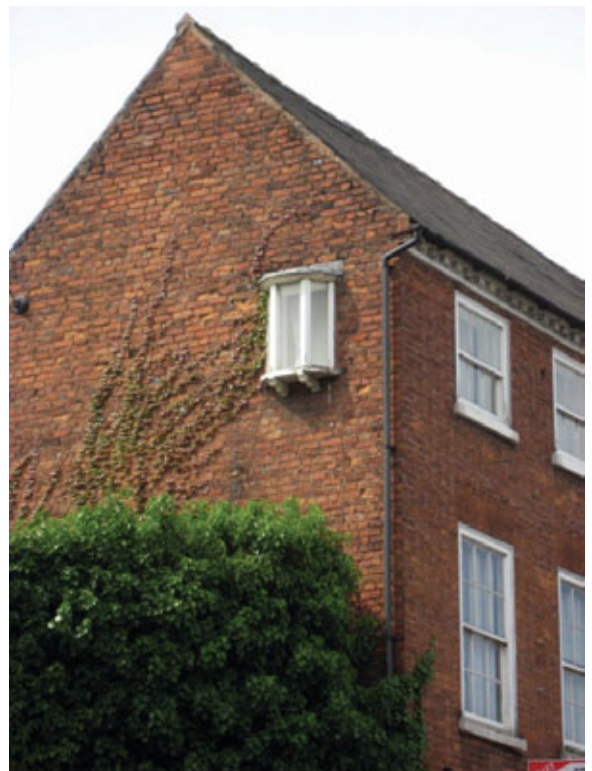
- Oriel window on east wall of No.1 St John's;

Oriel window enjoys views over floodplain.

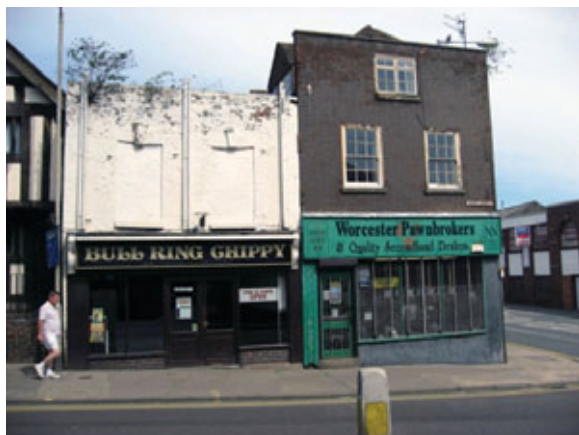
Some buildings are in poor condition, such as Nos.2 and 4 St Johns.

Buildings in the conservation area are generally in good condition but Nos.2 and 4 St John's are in a poor state of repair. The former cinema at No.73 and the adjacent properties up to No.79 have been damaged by fire and blighted during the supermarket development; they are in need of sympathetic repair and sustainable uses to enhance this corner of the conservation area.

Buildings in the conservation area are generally in good condition but Nos.2, 4 and 79 St John's are in a poor state of repair, as is the former cinema. Other vacant properties may also be at risk of decay.

ACTION: The Council will seek to monitor the condition of all historic buildings and, through the Heritage at Risk Register, will report findings and advise action, as necessary. Where the condition of a building gives cause for concern, appropriate steps will be sought to secure the future of the building, including the use of statutory powers.

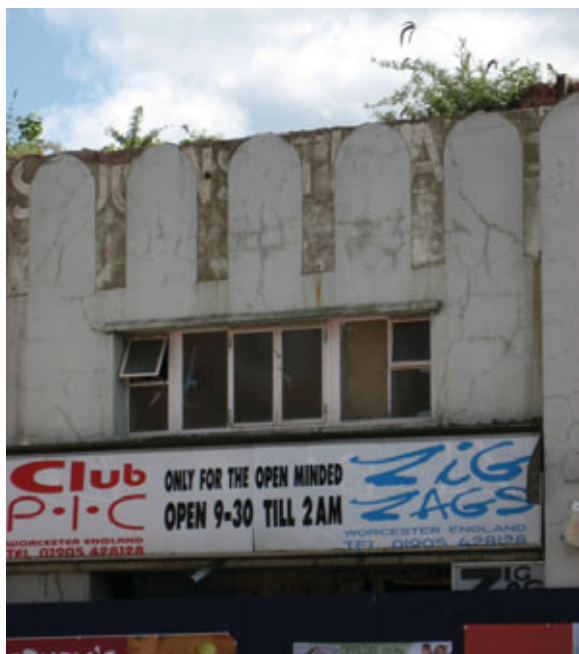
A ruin of negative impact - old cinema.

- Traffic noise and air pollution;
- Visually dominant 1970s tower blocks, outside the conservation area, but affecting the setting;
- Design of some 20th century development fails to preserve the area's predominantly 18th and 19th century architectural character e.g. cinema (in its present altered and fire-damaged appearance), Nos. 19-21 St John's (dated 1956) and the electricity sub-station in Bull Ring;
- The car show-room on Bransford Road opposite the southern boundary of the conservation area is inappropriate to the setting;
- Row of vacant and poorly maintained properties at south end of St John's (Nos. 71 to 87 including the former cinema);
