BEST PRACTICE PROGRAMME

Good Practice Case Study

1970's Civic offices designed and managed for low energy consumption

Hereford and Worcester County Hall, Spetchley Road, Worcester

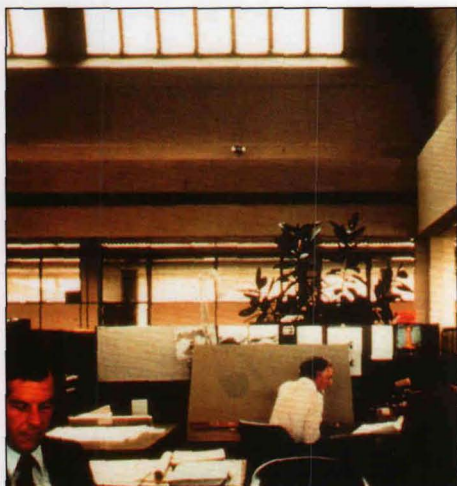
Rooflit top floor office core.

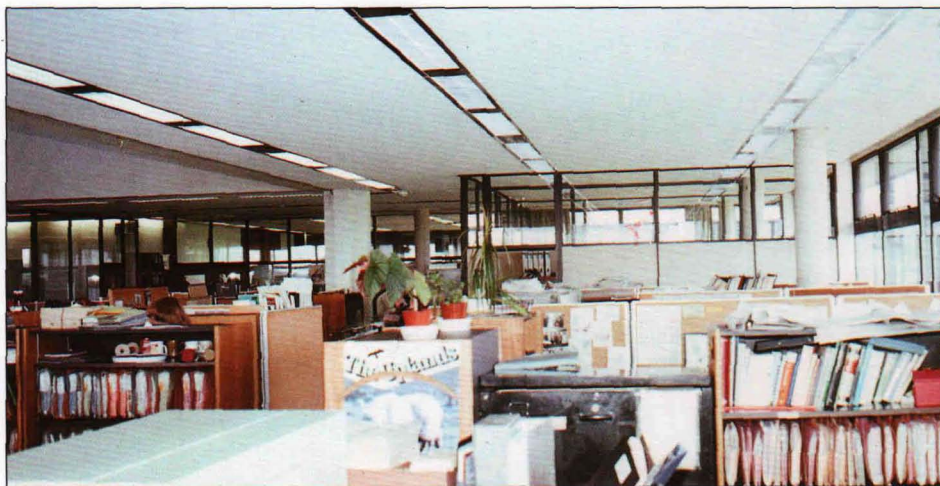
Perimeter offices. Note that the band of lights towards the window is off under automatic control.

The automatic control has under-performed partly because the continuous perimeter windows create an expectation of high levels inside, and partly because the lights are switched in groups — with all switches for each area in one panel — so there is a long walk when the lights go off. Although the switches are now labelled, people tend to switch everything on but are much less likely to switch anything off for fear of inconveniencing others.
